# Manhole Inspection Summary

Manhole # S29SS\_074MH

**Location** Address: **701 FALLS RD**

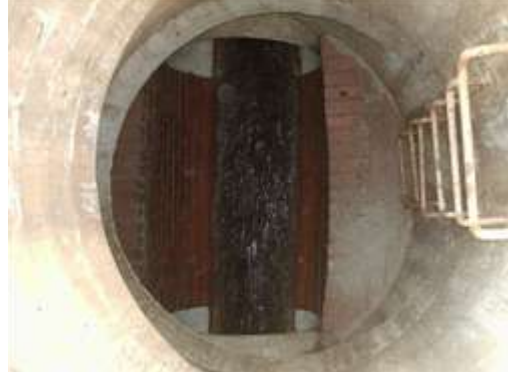
Top View

Bench debris.

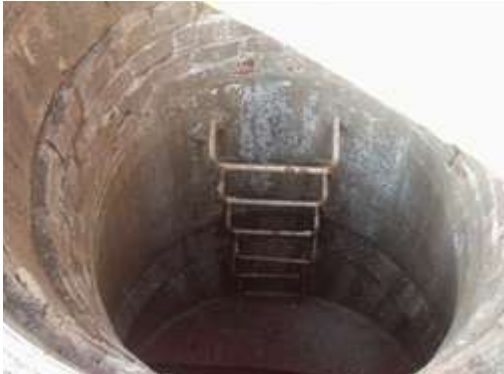
Defect

Frame leaks. Adjustment deterioration and infiltration. Corbel infiltration - other side.

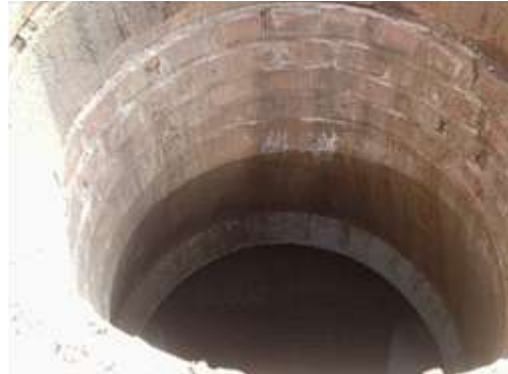
Defect

Frame leaks. Adjustment deterioration and infiltration. Corbel infiltration.

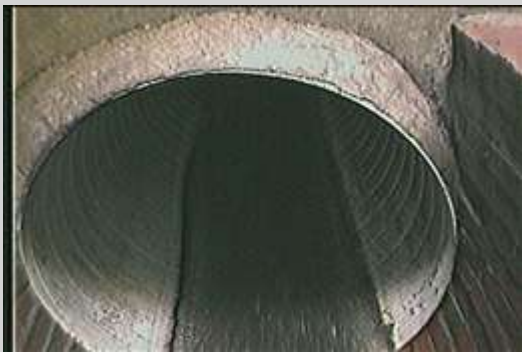
### 36 in. Circular Gravity Sewer Pipe Out @ 12 O'Clock

Pipe Material: **Unknown** ☒ Pipe Lined

Invert Depth: **12.00** (ft.) Flow Characteristics: **Fast**

Infiltration: **None** Pipe Seal Cond: **Unknown**

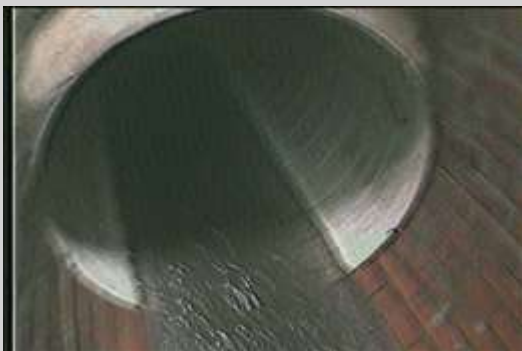
### 36 in. Circular Gravity Sewer Pipe In @ 6 O'Clock

Pipe Material: **Unknown** ☒ Pipe Lined

Invert Depth: **11.90** (ft.) Flow Characteristics: **Fast**

Infiltration: **None** Pipe Seal Cond: **Unknown**
